ARMY CONCEPT TEAM IN VIETNAM  
APO 143, San Francisco, California

⑨ MONTHLY TEST REPORT, NUMBER 3,

SUBJECT: Monthly Test Report Number 3 -- Mechanized Rifle Troop (M113)  
(1-30 April 1963) (U)

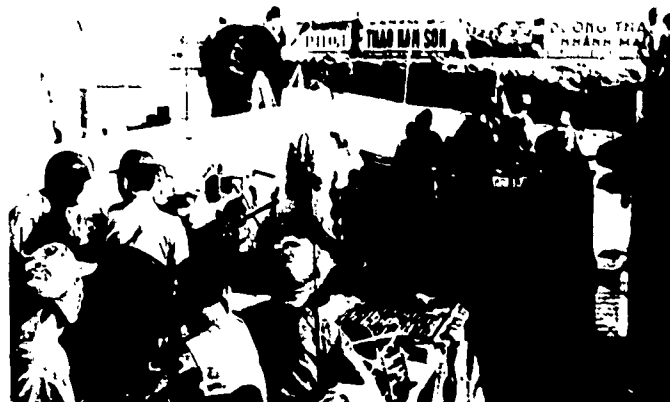
M113 troop disem-  
 barks. Unloading  
 required about five  
 minutes. The LCM  
 in the background  
 had previously un-  
 loaded.

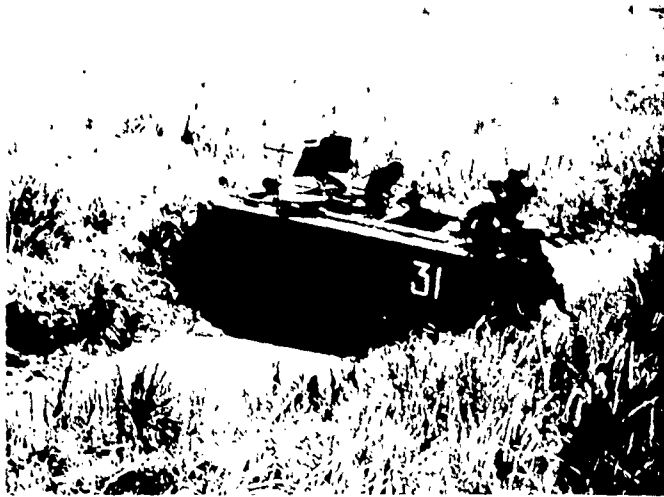
M113 stuck in a canal. The APC tried to buck through at high speed but could not breach the far bank.

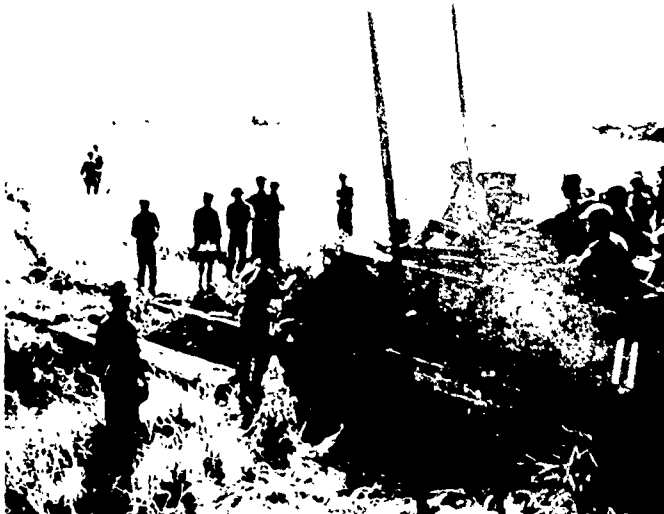
Narrow canal spanned with aluminum balk. Note tracks of APC that had crossed the canal previously.

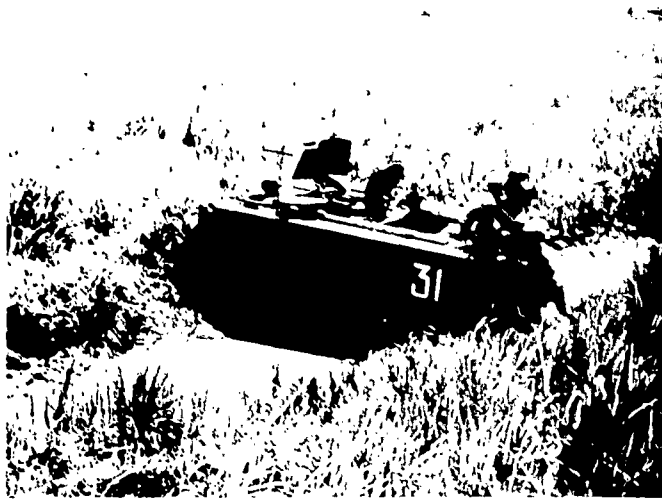
M113 stuck in a canal. The APC tried to buck through at high speed but could not breach the far bank.

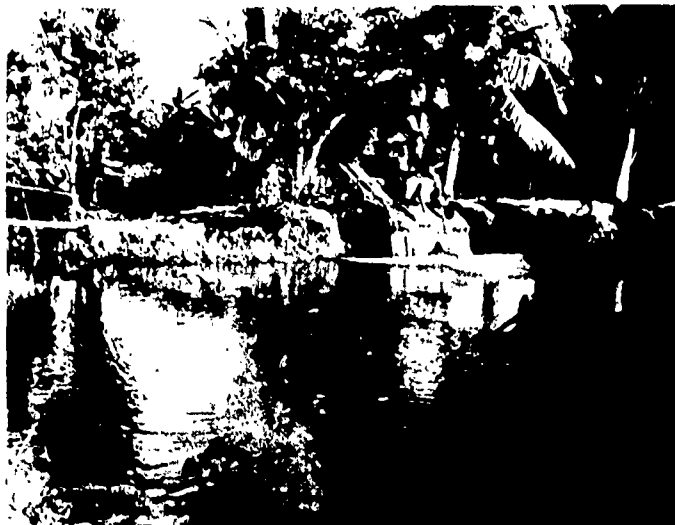
M113 enters canal.  
The crossing site  
had been prepared  
and used six months  
previously.

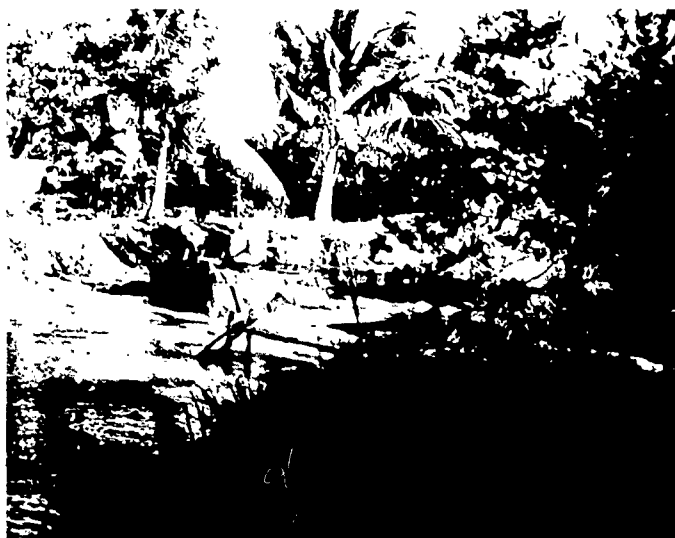
M113 in Mid-stream.  
Soldier in foreground,  
stripped to shorts,  
is working on the  
exit site.

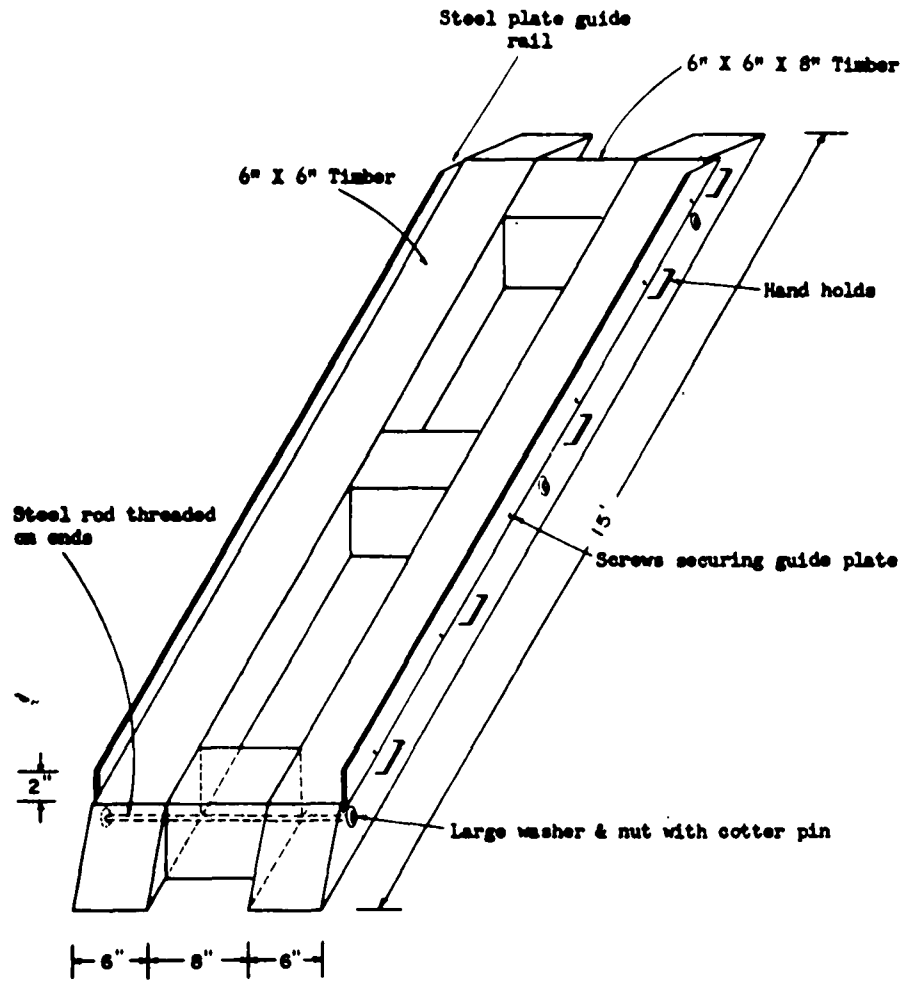
APPENDIX 3 to ANNEX F

PROPOSED CONCEPT FOR EXPEDIENT CANAL CROSSING TRUSS

Basis of issue - 6 per Company

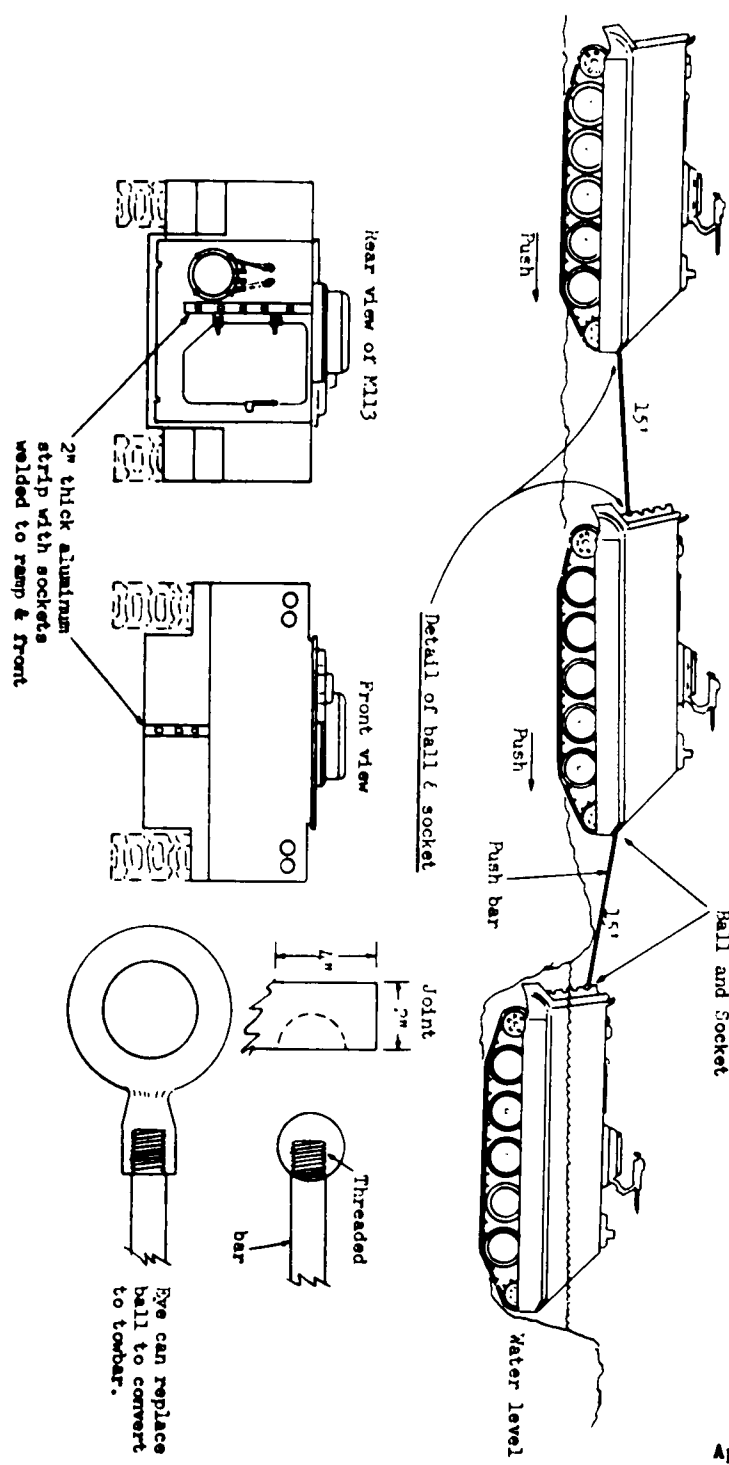
Appendix 4  
ANNEX F

# PROPOSED M113 PUSH-POLE SYSTEM
